**RESULTS OF A CULTURAL RESOURCES SURVEY
OF THE AVERY LANDING RAIL YARD PROJECT AREA,
SHOSHONE COUNTY, IDAHO**

July 20, 2012

APPLIED ARCHAEOLOGICAL RESEARCH, INC. REPORT NO. 1095

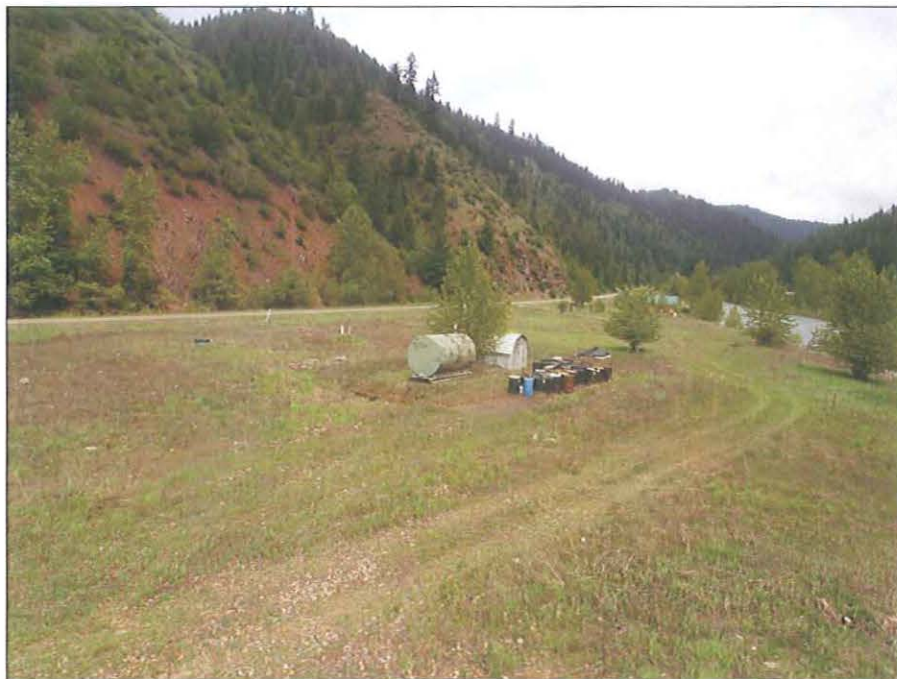
Figure 5. Overview of the main excavation zone in its current condition. A modern shed and storage container sit on top of a historic concrete pad (Feature 2, see below). View is to the northeast.

A concrete slab was observed at the eastern end of the Potlatch property just west of the section 15/16 line in an area that would have been in the center of the rail yard. It is 50 ft long east to west and 32 ft wide north to south (Figure 5). Its location and dimensions closely match those of the "Boiler House" depicted on the 1915 map (Figure 8). One complete brick was found next to the foundation/pad. The brick is machine made and tan in color. It is marked "309/SECURITY" (Figure 10). The mark identifies the brick as having been manufactured by the American Arch. Co. between 1910 and 1911 (Gurke 1987:294).

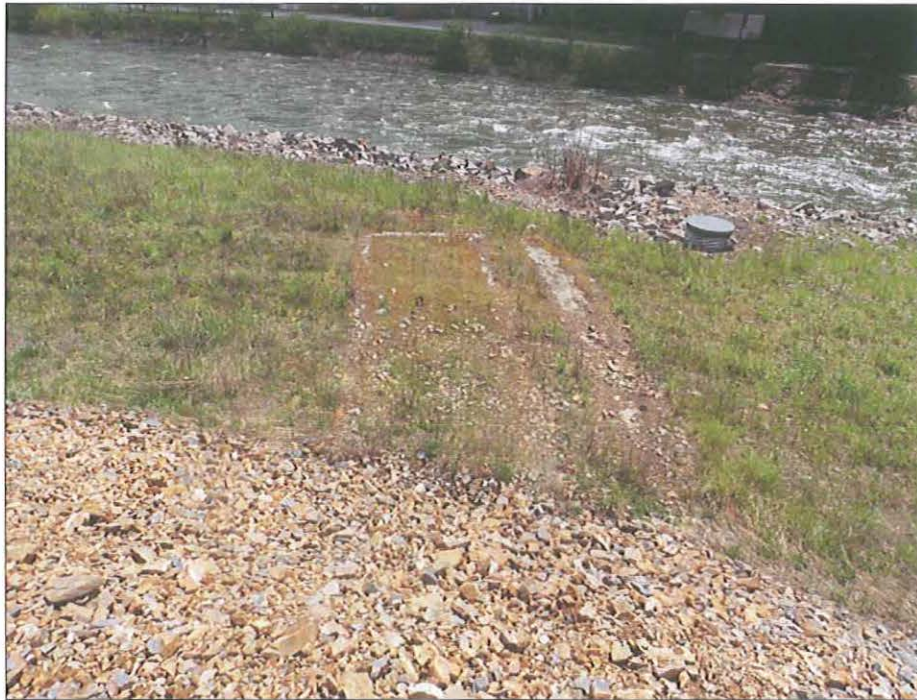
What likely is a concrete floor or foundation was identified in the south-central part of the project area near the river bank and a short distance west of the section 15/16 boundary. According to the 1915 map, it is in the vicinity of the southeastern part of the roundhouse and very near where the map shows a storage bay within the roundhouse to have been located (Figures 8 and 9). It was likely part of one of the 12 bay stalls where locomotives were stored or maintained. The feature is composed of two disconnected pieces of concrete. The larger of the two is rectangular in outline and minimally 1 foot tall. It frames an interior space filled with gravel and covered with grass. As observed it is 24 ft long and 8.5 ft across from outside edge to outside edge. The other part of the feature is a concrete footer or part of a foundation. It is 2 ft west of the first part. As observed it is 24 ft long and 3.25 ft wide. Both parts of Feature 1 extend northward and are covered by a large pile of rock. It is likely that Feature 5, described below, represents a continuation of Feature 1 on the north side of the rock pile. No artifacts were associated with Feature 1.

Figure 9. Photograph of Feature 1 looking southeast from atop the large rock pile located on Potlach property.

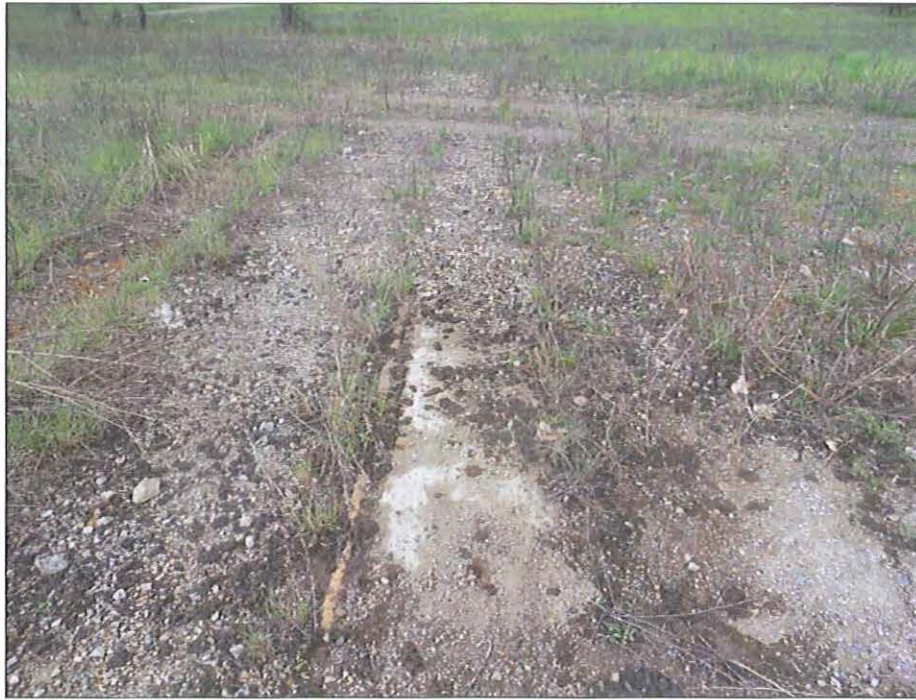
Metal railroad tracks laid in concrete were observed a short distance to the west of Feature 1 in the southern part of the project area. The location of the tracks corresponds well to where a storage bay and lead tracks are shown on the 1915 map (Figure 8). On the map the tracks are denoted to have been 129 ft, 1 inch long and connected the storage bay to the turntable. The observed section was approximately 15 ft long and 13 ft wide and would have been situated on the east side of the roundhouse.

As shown in Figure 11 the inside of the roundhouse where trains were kept in storage bays included tracks and a concrete floor very similar to the arrangement of Feature 3. Specifically, the feature consists of one 2-inch thick metal rail next to an approximate 12-foot wide concrete slab (Figure 12).

Figure 12. View of Feature 3 that represents one set of lead tracks that were used to move locomotives and train cars between the turntable and the storage bays in the roundhouse. View is northwest.

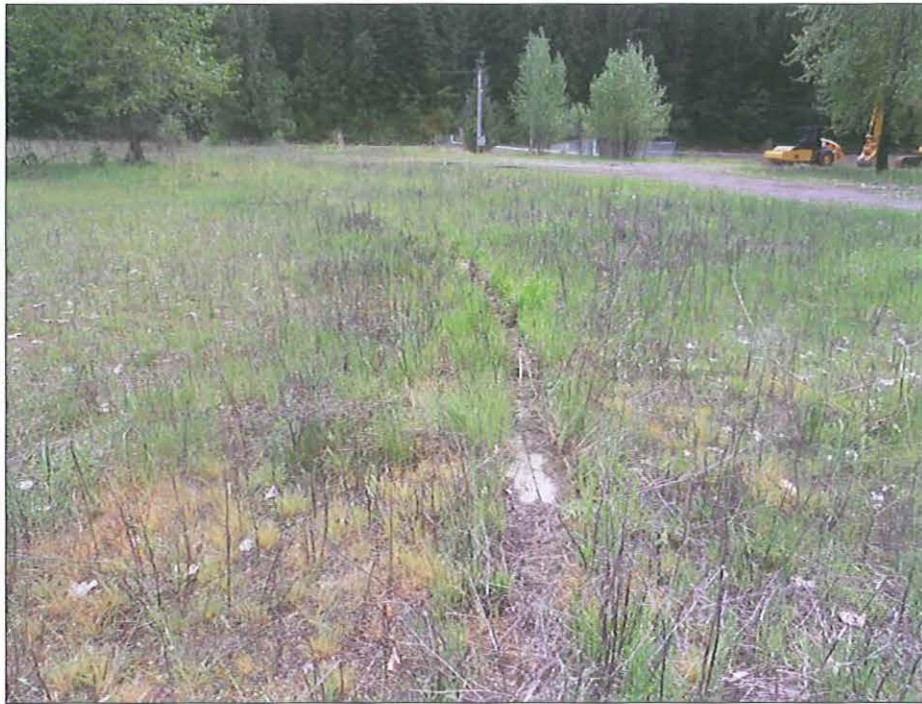
Feature 4 is located just south of Highway 50 in an area that would have been toward the center of the Avery Division rail yard (Figure 8). The feature is part of a circular concrete footer or foundation that represents an interior element of the railroad turntable that was used to move and position locomotives (and rail cars) between the main rail tracks to lead tracks that led into the roundhouse storage bays. Feature 3, described above, is an example of a lead track. The turntable was a large, round, concrete feature that was 107 ft in diameter and consisted of two tiers (Figure 8). Feature 4 is part of the interior, lower tier. Its function is unknown but it may have served as the surface upon which the turntable rotated (Figure 13). Feature 4 is approximately 20 ft long and 16 inches wide (Figure 14). Attempts to follow the arcing footer/foundation were unsuccessful and it may be buried beneath the ground surface. Following the arc of the exposed part led to several large pieces of concrete rubble that likely represent a demolished section of the turntable (Figure 15).

Figure 15. Feature 4, concrete foundation of the interior section of the turntable.
View is to the south.

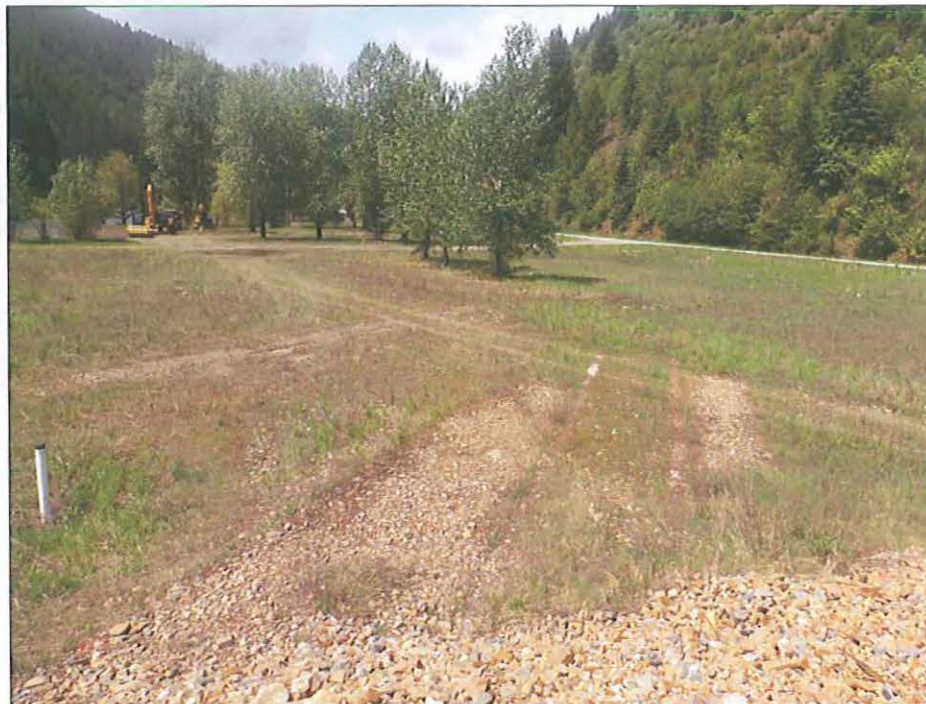
Feature 5 consists of a section of lead tracks that would have been between the turntable and the roundhouse or partly within the roundhouse. The tracks are marked by two parallel indentations on the ground surface, where rail track has been removed, surrounded by concrete. Another set of lead tracks, Feature 3, oriented parallel to Feature 5, are located just to the west (Figure 16). Feature 5 is 40 ft long and 5 ft wide. It extends southeastward to a large rock pile. Feature 1 is in line with it and the two features appear to represent most of the length of a single set of lead tracks.

Figure 16. Feature 5, concrete floor and lead track lines. Another set of lead track, Feature 3, can be seen to frame left. View is northwest.

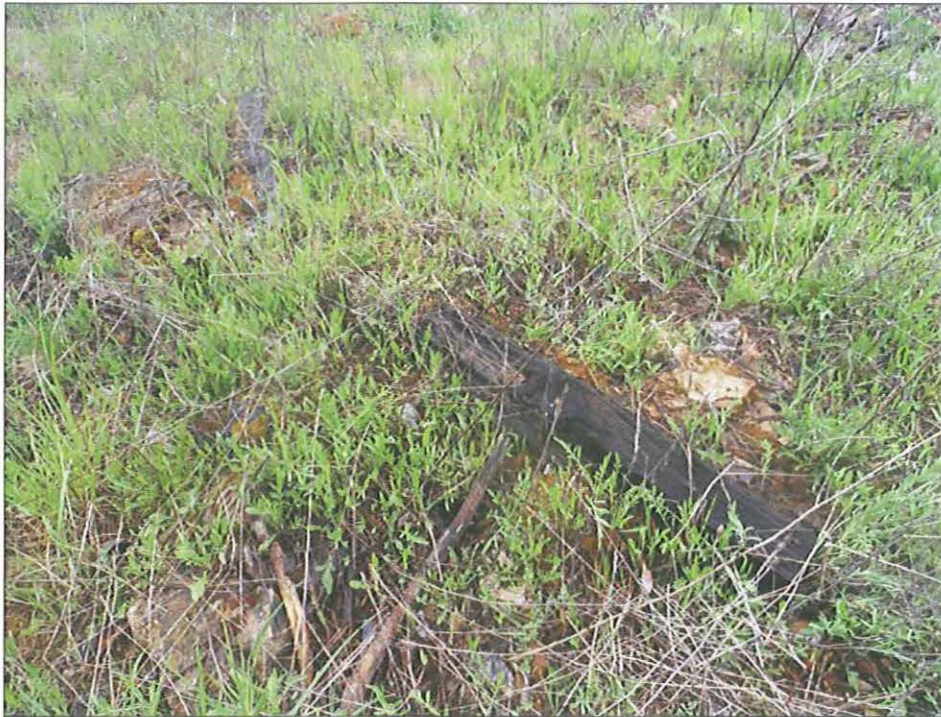
Located in the easternmost part of the project area within the Benticik property at the top edge of the river bank, this scatter of modern and historical debris included a corroded wire, two wooden railroad ties, one concrete fragment, milled wood, and three pieces of modern bottle glass (Figure 17). Items identifiable as more than 50 years were mixed together with objects of undeterminable age and items that were modern. The historical items were observed scattered in an area measuring approximately 100 ft east to west and 20 ft wide north to south. Materials included items of architectural character and more specifically were attributed to the Avery Division rail yard deconstruction.

Figure 17. Photo of Scatter 1 located in the easternmost part of the project area.

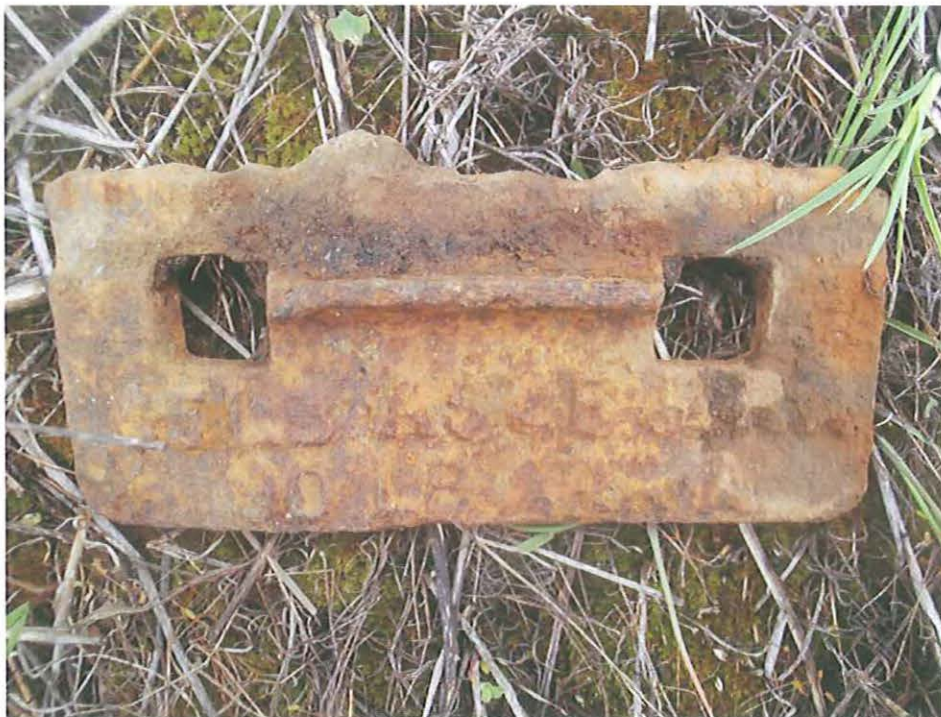
The historic-era scatter is situated on level terrain, just south of Highway 50 within the Benticik property. It consists of a sparse scatter of domestic and architectural debris over an area of 150 ft by 100 ft. Artifacts noted include one piece of aqua-colored bottle glass, one undecorated fragment from a ceramic bowl, three railroad spikes and a metal railroad plate that was marked "55 LB AS_E & RR/90 LB ARA A" (Figure 18), several pieces of terra cotta sewer pipe, and two slabs of concrete.

Figure 18. Railroad-related artifact found within Scatter 3.

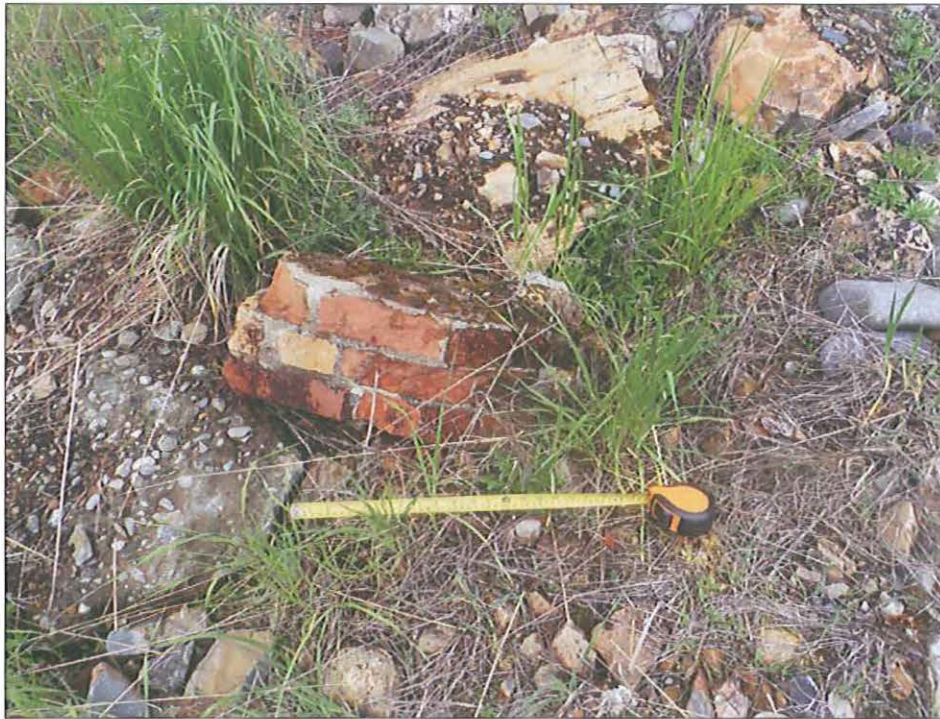
Scatter 4 is located on the Potlatch property immediately west of Feature 2 and covers an area approximately 140 ft long and by 40 ft wide. At the ground surface it includes two pieces of aqua bottle glass, about 12 whole bricks (both red and tan), several bricks attached together with mortar, and large concrete pieces (Figure 19). No maker's marks were noted on the glass or brick items. The debris is mostly architectural and likely related to demolition of the roundhouse and associated buildings of the rail yard.

Figure 19. Structural debris included in Scatter 4.

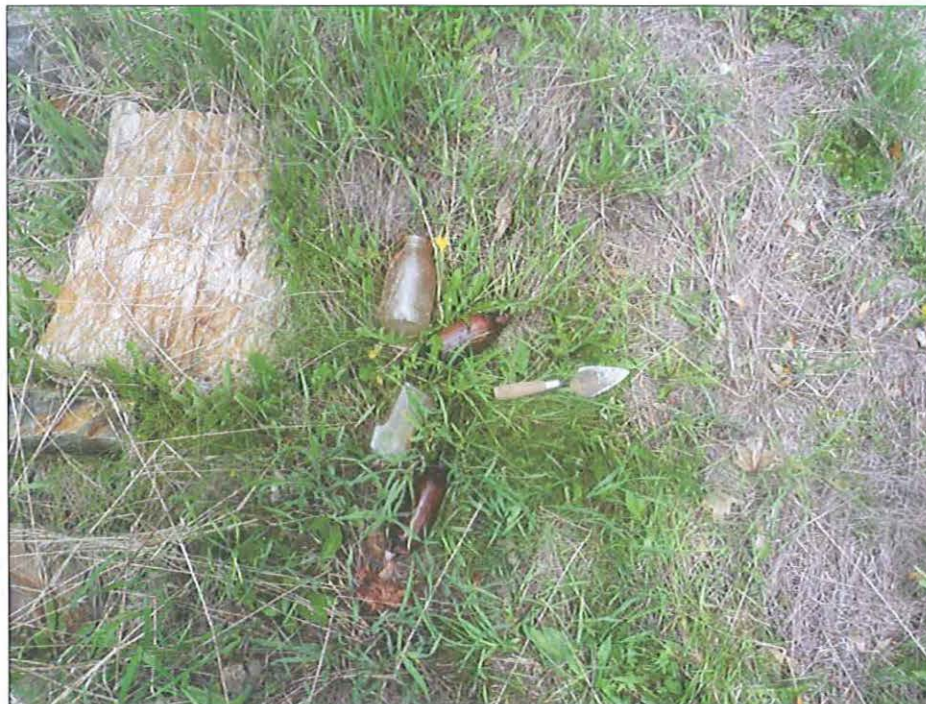
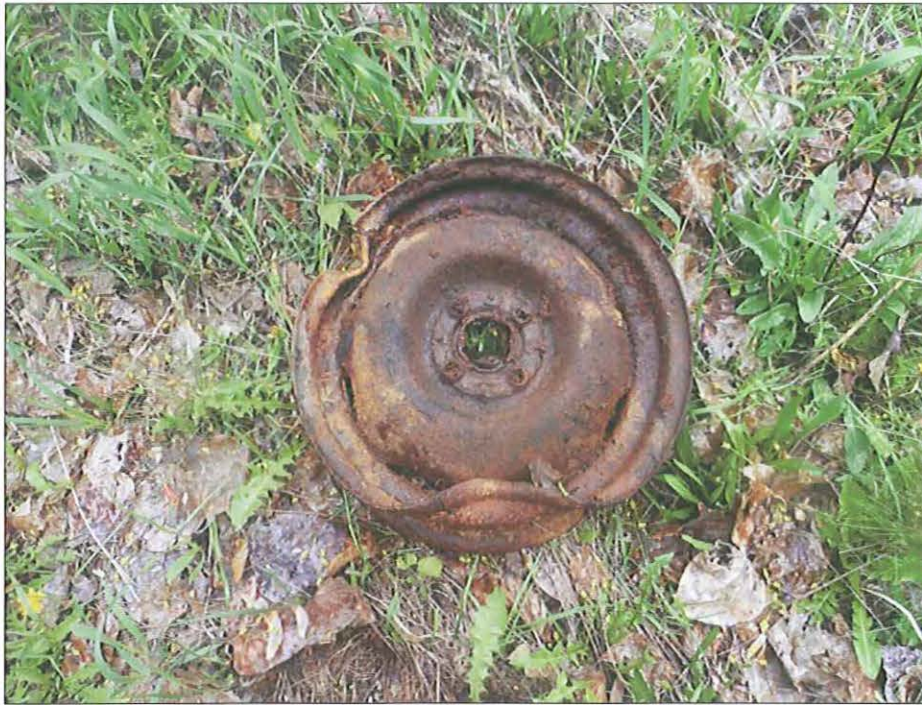
This scatter is located at the western end of the project area, next to the bank, and includes four historical bottles (Figure 20) and one train railcar wheel (Figure 21). The train wheel is 17 inches in diameter, made of metal, and is located 10 ft north of the bottles. Two of the glass containers are amber beer bottles, one is a colorless milk bottle, and the other, also colorless, is a flask. The colorless containers show no hint of amethyst coloring, which is indicative of the use of manganese dioxide as a decoloring agent in the glass, which if present would date the bottles to ca. 1880-1925 (Newman 1970). Each bottle is embossed on its base with a makers' mark. Two of them feature the oval-diamond-I trademark for the Owens-Illinois Glass Company (Toulouse 1971:403) and the other two are embossed with a connected "NW" for the Northwestern Glass Company.

Figure 20. Bottles included in Scatter 5. Trowel points north.

Figure 21. Train wheel included in Scatter 5.

The Northwestern Glass Company has used the connected “NW” trademark since 1931 (Toulouse 1971:390), while the oval-diamond-I trademark for the Owens-Illinois Glass Company was in use from 1929 to 1954 (Toulouse 1971:403). The number “7” appears to the right of the trademark on the Owens-Illinois flask, in the place where, according to Toulouse (1971) and Lockhart (2010), the year of manufacture should be located. It is likely that this single digit number represents 1937 because after 1940, Owens-Illinois began to use double digit year codes (Bill Lockhart, personal communication to Jessica Hale, May 1, 2010). The other Owens-Illinois container is a beer bottle and is embossed on the base with the number “47” to the right, which undoubtedly represents 1947.

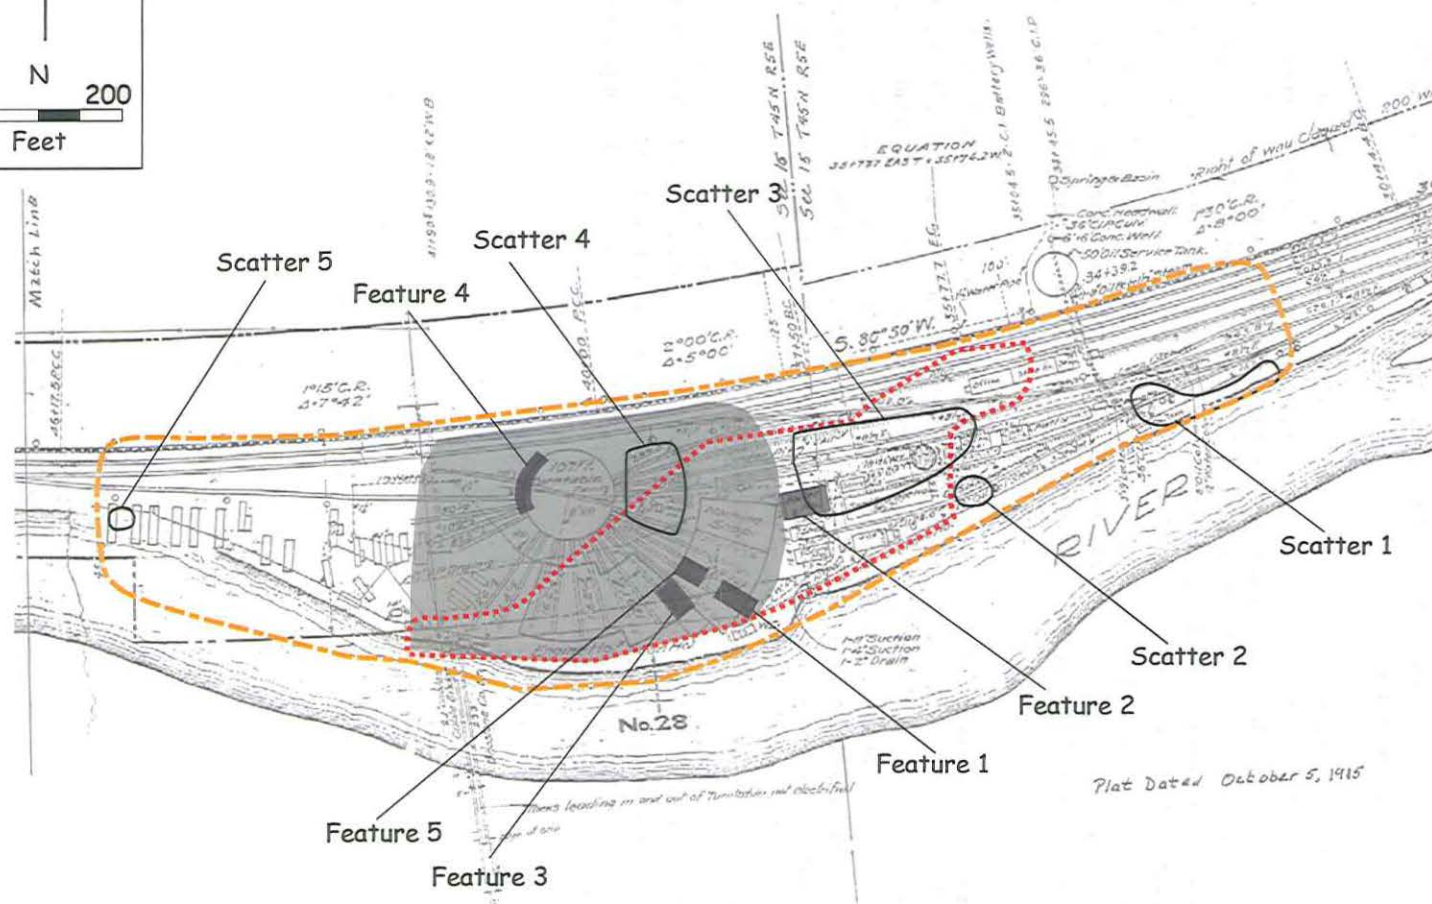
Figure 22. Showing the location of recommended monitoring (shaded gray), site boundaries (orange dashed line), features and scatters recorded and the estimated Current Free Product Plume (red dashed line) overlaid on the 1915 Avery Landing Train Station Schematic map.

The cultural inventory of the Avery Division rail yard is not considered to be complete because the presence or absence of subsurface deposits related to site 10SE476 has not yet been verified. To complete the cultural resources inventory and to provide a more definitive evaluation of the site's eligibility to be listed on the NRHP AAR makes two recommendations in consideration of the site's industrial character and the fact that much of it is covered by, and possibly contained within, contaminated sediment. The first is that a cultural resource monitor watch any earthmoving or other ground-disturbing activities in the part of site 10SE476 that contains Features 1, 3, 4, and 5, that are related to the turntable and roundhouse (Figure 22). During monitoring an archaeologist would closely observe the excavations in the area where the turntable and roundhouse were located to ensure that important details on the layout, construction, and engineering of those facilities are not destroyed by the remediation efforts. Excavations in the area shown shaded in Figure 22 should involve a piece of equipment mounted with a toothless bucket removing shallow lifts of no more than 6-inch thickness. If at any point during the excavations the monitor encounters features (or other type of archaeological deposits) and believes that further examination of them is warranted, all ground disturbances must halt within 100 ft of the designated area. Because of details of layout, construction, and engineering that are of interest may not be adequately exposed using heavy equipment, it may be necessary for the cultural resources monitor to manually excavate loose soil away from exposed features using a flat-nosed shovel. Note that because the site is contaminated, the cultural resources monitor will need to have had hazardous waste operations and emergency response training.

It is expected that the subsurface part of the features present in and around where the turntable and roundhouse were located are shallowly buried so that after they been adequately documented, excavations using a toothed-bucket and thicker lifts may resume without a monitor in place.
